Friends Lake Watershed Assessment

The Town of Chester

Developed by the Warren County Soil and Water Conservation District

October 2017

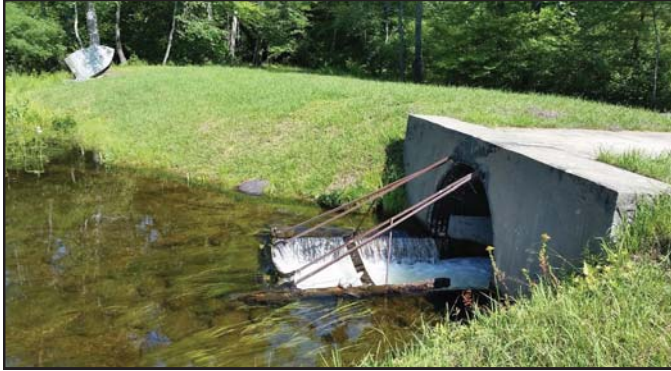
Figure 5 Friends Lake dam, WCSWCD

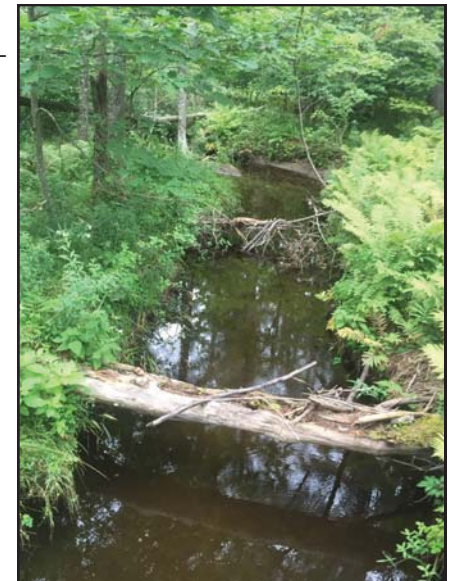
Figure 7 Outflow from Sullivan Pond, WCSWCD

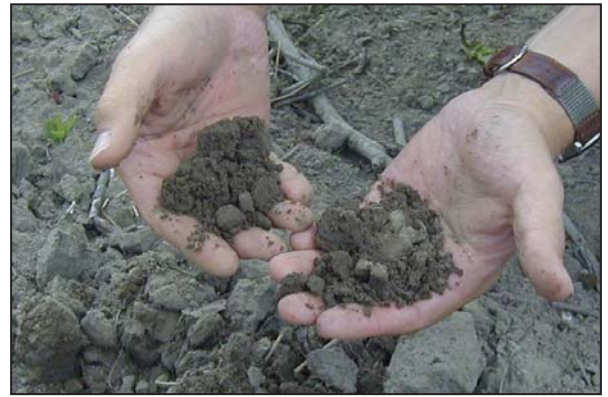
Figure 17 Soils atypical of Warren County, Hydrologic Soil Group D, WCSWCD

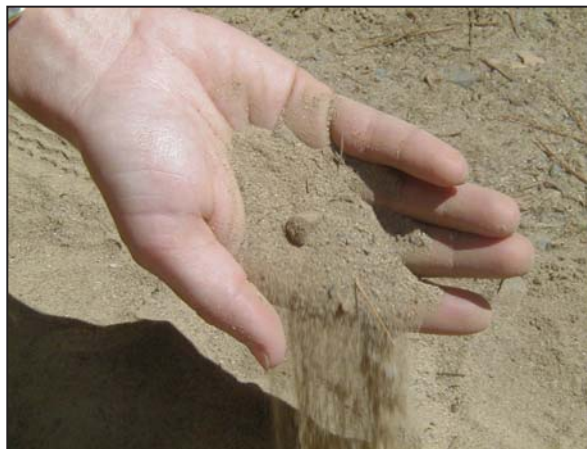
Figure 18 Example of coarse, sandy soils typical of Warren County (Hydrologic Soil Group A), WCSWCD

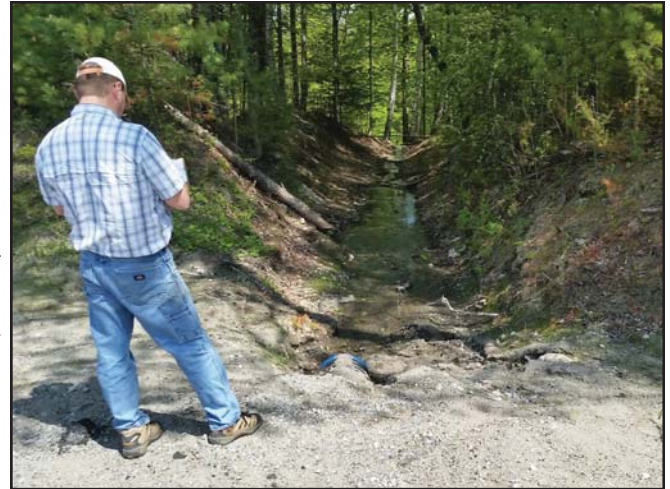
Figure 21 Inspection of a roadside culvert crossing, WCSWCD

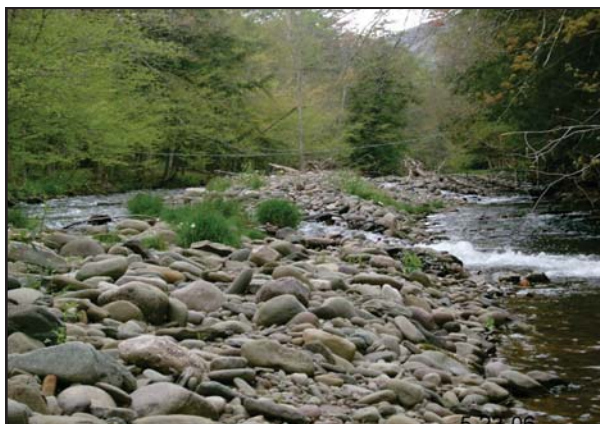
Figure 22 Example of center bar deposition
Courtesy of Delaware County SWCD

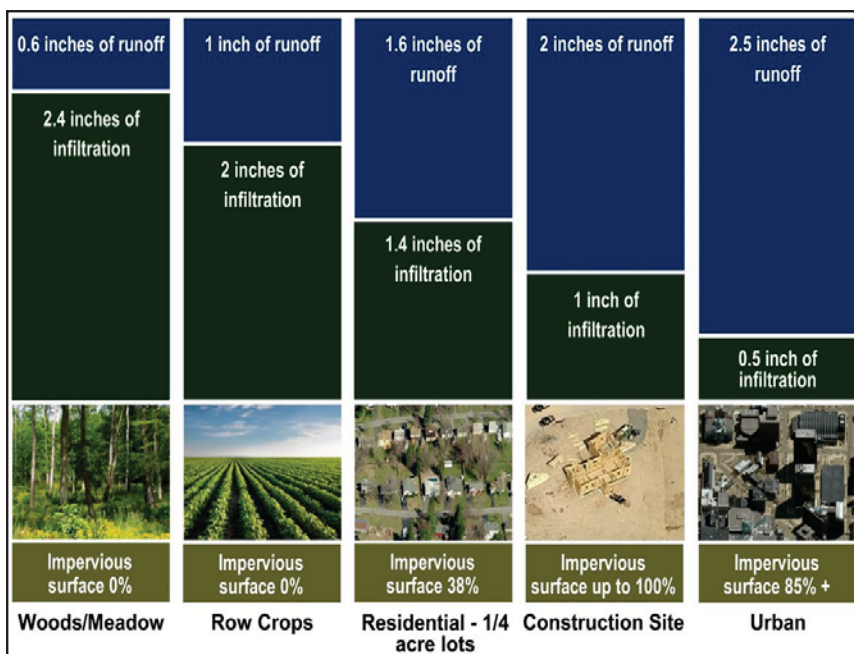
Figure 23 Represents the infiltration rate based on common impervious surfaces.
Image from the New York State Department of Environmental Conservation.

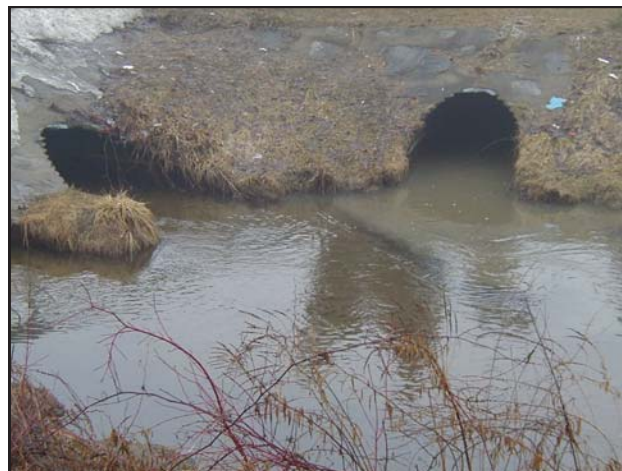
Figure 24 Stormwater runoff, WCSWCD

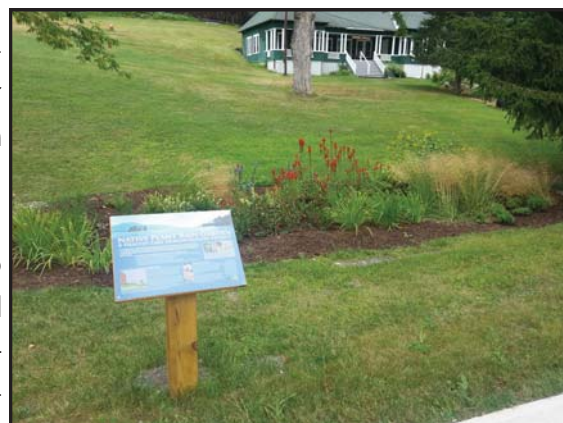
Figure 25 Rain garden on Lake George,
Photo courtesy of LGA

According to the University of Rhode Island's Healthy Landscaping program, a rain garden is "a planted depression or a hole that allows rainwater runoff from impervious urban areas, like roofs, driveways, walkways, parking lots, and compacted lawn areas, the opportunity to be absorbed. This reduces rain runoff by allowing stormwater to soak into the ground (as opposed to flowing into storm drains and surface waters which causes erosion, water pollution, flooding, and diminished groundwater). Rain gardens have become quite popular for addressing stormwater runoff for landowners. These are specifically sited to allow water to collect and infiltrate instead of directly running off a property. Specific plants are selected that will thrive and provide water quality benefits. In many rain gardens, plants such as Joe-Pye Weed, New England Aster or various ferns are planted, however the plants should be native to the area to ensure their survival.

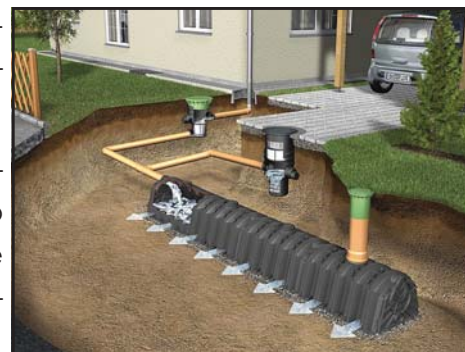
Figure 26 Residential infiltration, The Code Store, United Kingdom

If the soil conditions allow for infiltration, then roof gutters and driveway runoff may be directed to an infiltration structure. This will help reduce downstream volumes and will aid in recharging the groundwater. These structures may require some maintenance depending on the amount of sediment and debris they receive.

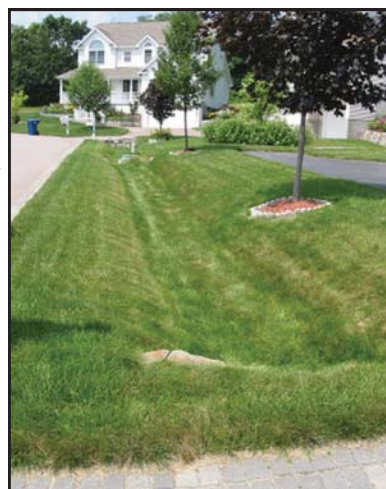
Figure 27 Grassed swale, Virginia Cooperative Extension

Put simply, a grassed swale is a low area that collects water and allows for infiltration and nutrient uptake. Swales can be very effective in treating stormwater as they can detain water for periods of time allowing vegetation to readily utilize the water and phosphorus. These are minor practices and can be successfully installed in many locations on a property. A swale may be wet or dry.

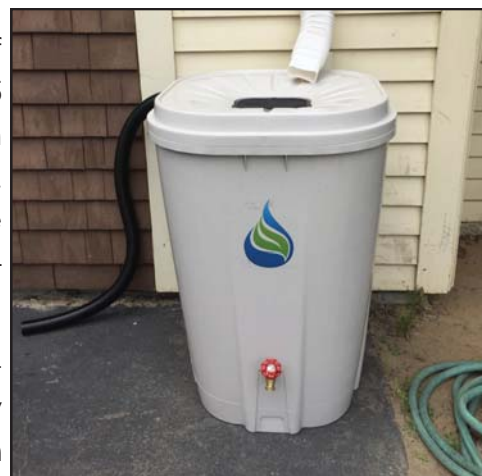
Figure 28 Rain Barrel, WCSWCD

Cisterns and rain barrels function in similar ways. They collect roof water runoff and store it for irrigation. Typically rain barrels are 55 gallons and have an overflow feature. Some landowners will run a series of rain barrels to collect larger volumes of water for use. Rain barrels are available from a variety of companies, but are also very easy to make and can be a simple and fun family project.

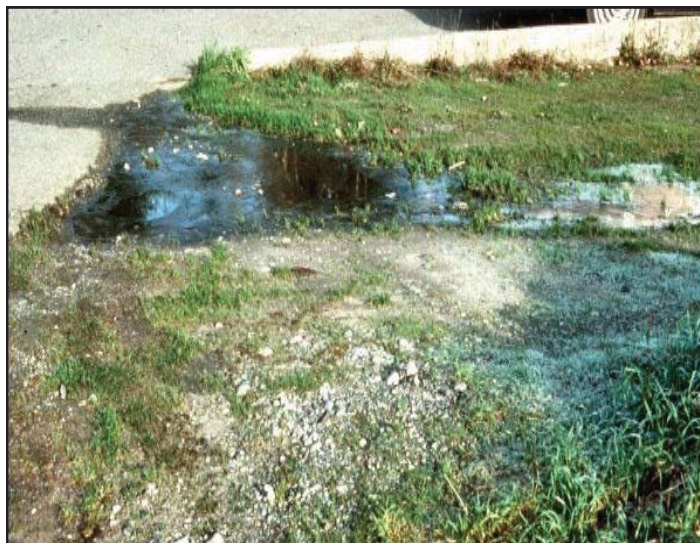
There are two types of septic failures that may occur: surface and subsurface. The surface failure is one that many people would recognize. A dark water that appears on the ground around their septic system, especially with a foul odor, is typical of a surface failure this is the more easily recognizable failure. A subsurface failure is more difficult to ascertain as it is below the ground. If a local waterbody has experienced an increase in productivity, and there are no other potential source of nutrients, then the septic system may have a subsurface failure. Nutrient and bacterial testing may be needed to confirm this.

*Figure 30 Surface septic failure
Image courtesy of EPA and King County, WA*

In order to reduce the likelihood of a septic failure, routine maintenance needs to be conducted. The first step is to identify the style and the location of the system. Understand how your system is designed to function (i.e. is it a traditional system, is it a dosing system, is it gravelless) and if there are any special requirements. In general it is good to pump out and inspect a system every 3-5 years. If there is a food waste grinder or additional people in the house long term, then the pump out frequency should be increased. Reduce the use of harsh chemical going to the system for treatment. Many household items that are used should not be disposed of down a drain, and that goes for too many antibacterial products. The antibacterial soaps cannot differentiate between "good" or "bad" bacteria, and an excessive amount in a septic system can kill off the good bacteria that help the system function. To find out more about septic systems, visit <http://www.soil.ncsu.edu/publications/Soilfacts/AG-439-13/> or contact the Town of Chester.

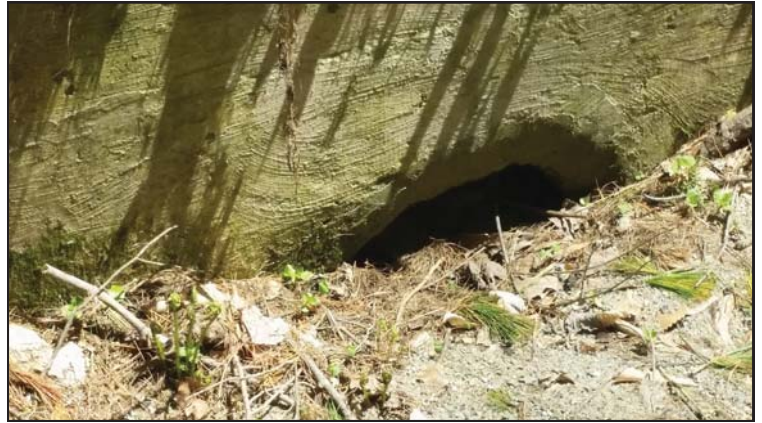
Figure 31 Culvert that is full of sediment and debris, WCSWCD

The critical components are correctly sized and vegetated roadside ditches, hydroseeding of newly formed ditches, and check dams on the steeper slopes. In addition, the municipalities should install infiltration structures wherever possible and reduce the number of the direct turnouts from the roads to the stream. The more efficient application of winter de-icing materials is also an important discussion to have with town officials. Excessive amounts of sand and salt will have negative effects on the health of streams. Encouraging the municipalities to use BMP's will improve water quality conditions within the watershed.

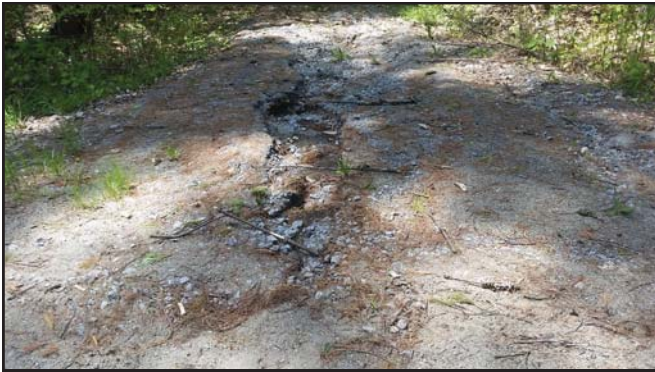
Figure 32 Driveway head-cut, WCSWCD

There are a considerable amount of private roads that surround the shoreline of Friends Lake. These unimproved roads should be maintained to reduce the influx of sediment and associated nutrients entering directly into the lake. Maintaining a good crown on unimproved roadways will prevent or reduce rutting and head-cuts that are produced during high flow runoff events. Clearing the roadside ditches and culverts of accumulated sediment and debris will inhibit over-topping of the road

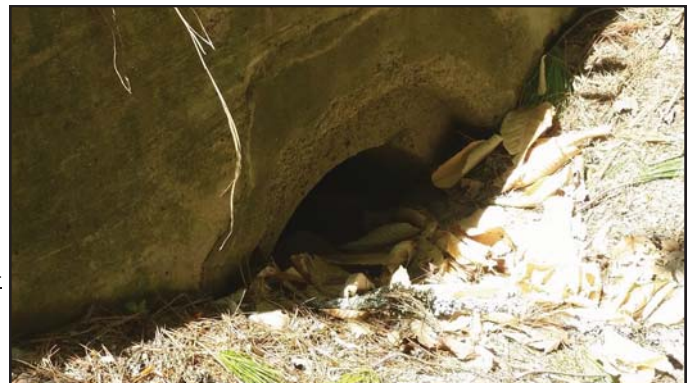
Figure 33 Roadside culvert crossing, WCSWCD

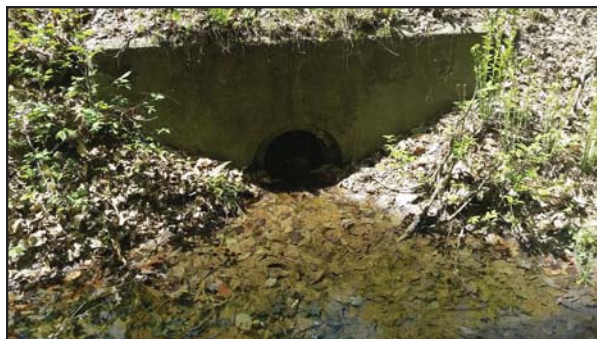
Figure 34 Culvert crossing, WCSWCD

Continued maintenance of roadside ditches and culverts is necessary for the proper functioning of the stormwater system. Several culverts along this road have become obstructed with accumulated sediments. Ditches need to be cut to appropriate depths and the newly bared soils re-seeded so they are well vegetated. In addition, check dams need to be properly placed along the steeper sections to slow runoff velocities and the accumulated sediments need to be removed from the culverts. This will prevent the existing ponding at the inflow side of the culverts along the road.

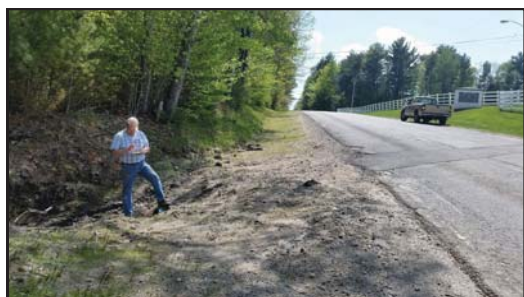
Figure 35 Culvert crossing, WCSWCD

Figure 35 on the northeast side of county route 8 would be an ideal location for erosion and sediment control improvements. It is recommended that there be a more defined vegetated ditch on the east side of the road and to install rock check dams along the pitched roadway. In addition, the existing stormwater runoff path should have a ditch turnout with outfall protection matting. Protective matting should also be installed at the culvert invert from the drop inlet on the opposite side of the road. The addition of a series of stone check dams should be placed in this newly expanded stormwater ditch.

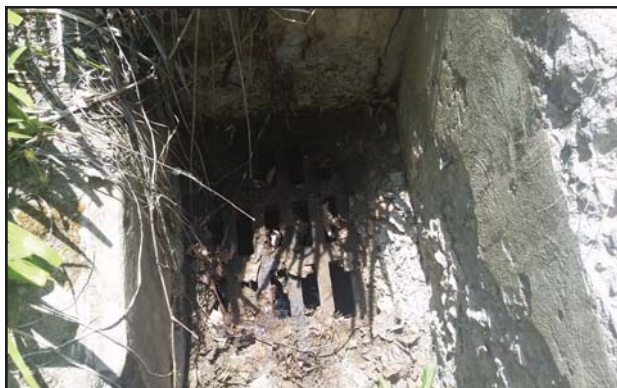
Figure 36 Drop inlet, WCSWCD

Seasonal maintenance of the roadside ditches and culverts is necessary for the stormwater system to work. Culverts along this section of the road have become obstructed with accumulated sediments. The buildup of sediment is a direct result of the culverts being undersized and the ditches lacking vegetation. The ditches need to be cut to appropriate depths and the disturbed soils re-seeded to establish vegetation.

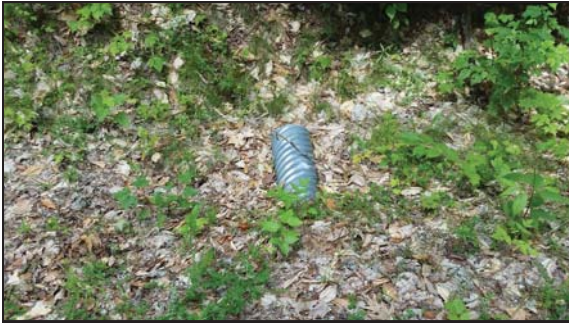
Figure 37 Culvert crossing, WCSWCD

General conditions along this road are in good shape. However there are two recommendations for improving the road's condition. The placement and spacing of drainage culverts along the road

prevent scour of the water way and reduce the amount of sediment flowing toward the lake. On the steep section of the road approximately 0.35 miles southeast from Hill Park Road, the application of water bars should be used to direct stormwater off the road and into the expanded ditches. The use of rock check dams or concrete sediment traps in the ditches at this steeply pitched location will reduce head-cutting on the road, damage to the ditches, and decrease sediment from building at the low end culvert.

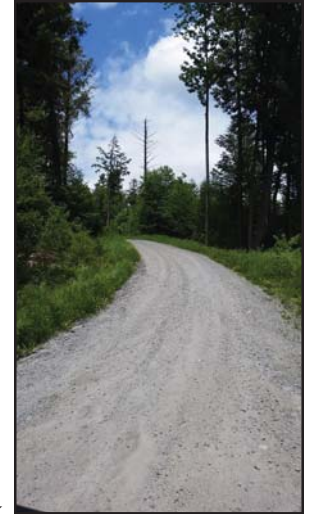
Figure 38 McPhillips Pine Road, WCSWCD

are well designed, but when the current culverts are in need of replacement the present culverts should be larger. The current 8" or 10" diameter culverts should be upsized to 15"+ diameter culverts. The correctly sized culverts will prevent pooling at the inflow invert and reduce the velocity of the flow leaving the culvert. This will

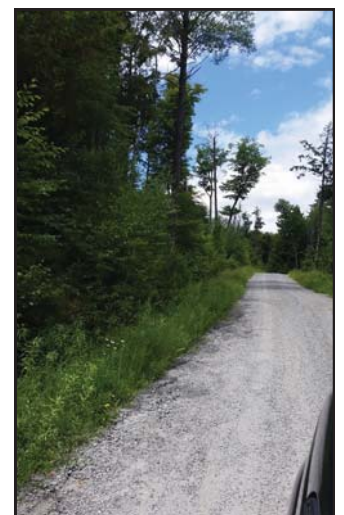
Figure 39 Culvert crossing, WCSWCD

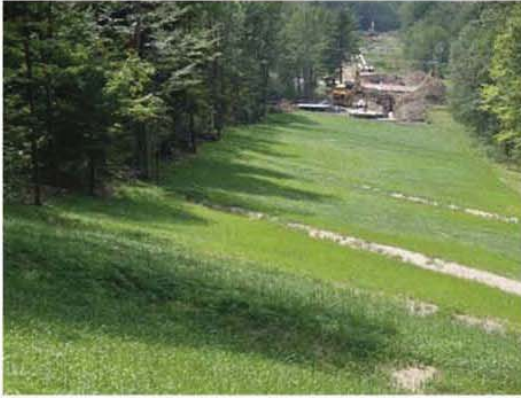
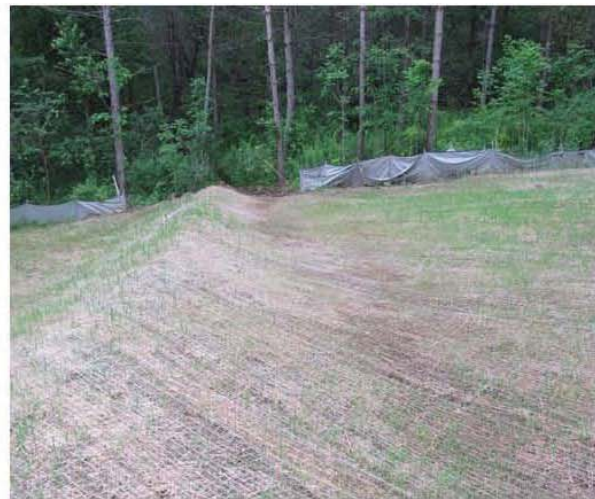
STANDARD AND SPECIFICATIONS FOR WATER BAR

A **permanent** or **temporary** ridge, ridge and channel, a structural channel, or flow deflector, constructed diagonally across a sloping road or utility right-of-way that is subject to erosion to limit the accumulation of erosive velocity of water by diverting surface runoff at pre-designed intervals.

5. The positive grade of the water bar shall not exceed 2%. A crossing angle of approximately 60 degrees is preferred.
6. Once diverted, water must be conveyed to a stable system (i.e. vegetated swale or storm sewer system). Water bars should have stable, unrestricted outlets, either natural or constructed.

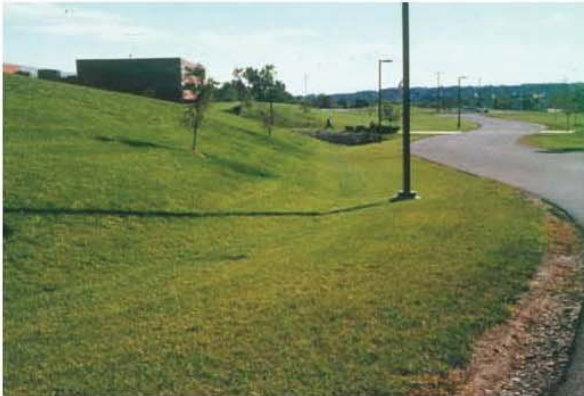
STANDARD AND SPECIFICATIONS FOR GRASSED WATERWAY

A natural or **permanent** man-made channel of parabolic or trapezoidal cross-section that is below adjacent ground level and is stabilized by suitable vegetation. The flow channel is normally wide and shallow and conveys the runoff down the slope without causing damage by erosion.

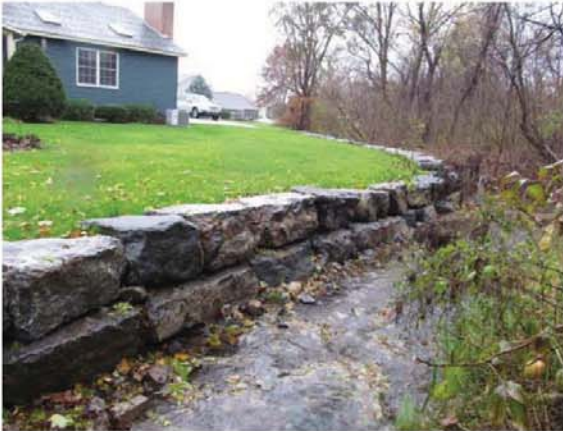
STANDARD AND SPECIFICATIONS FOR RETAINING WALLS

A **permanent** structural wall constructed and located to prevent soil movement by retaining soil in place and preventing slope failures and movement of material down steep slopes.

The design of any retaining wall structure must address the aspects of foundation bearing capacity, sliding, overturning, drainage and loading systems. **These are complex systems that should be designed by a licensed professional engineer.**

1. Foundation will be prepared by excavating to the lines and grades shown on the drawings and removing all objectionable material.
2. Subgrade will be compacted and kept moist at least 2 hours prior to placement of concrete.
3. Steel reinforcing will be in accordance with the schedule on the drawings and kept free of rust, scale, or dirt.
4. Exposed edges will be chamfered $\frac{3}{4}$ inches.
5. Drainfill will meet the gradations shown on the drawings.

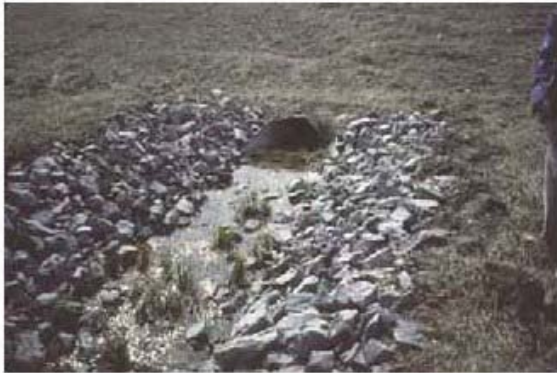
STANDARD AND SPECIFICATIONS FOR ROCK OUTLET PROTECTION

A section of rock protection placed at the outlet end of the culverts, conduits, or channels.

The depth of tailwater immediately below the pipe outlet must be determined for the design capacity of the pipe. If the tailwater depth is less than half the diameter of the outlet pipe, and the receiving stream is wide enough to accept divergence of the flow, it shall be classified as a Minimum Tailwater Condition; see Figure 5B.12 on page 5B.25 as an example. If the tailwater depth is greater than half the pipe diameter and the receiving stream will continue to confine the flow, it shall be classified as a Maximum Tailwater Condition; see Figure 5B.13 on page 5B.26 as an example. Pipes which outlet onto flat areas with no defined channel may be assumed to have a Minimum Tailwater Condition; see Figure 5B.12 on page 5B.25 as an example.

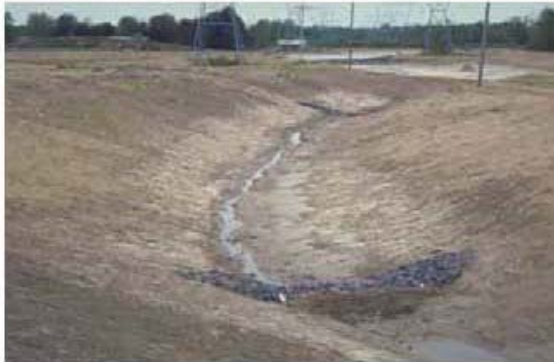
STANDARD AND SPECIFICATIONS FOR CHECK DAM

Small barriers or dams constructed of stone, bagged sand or gravel, or other durable material across a drainage way.

The check dams should be inspected after each runoff event. Correct all damage immediately. If significant erosion has occurred between structures, a liner of stone or other suitable material should be installed in that portion of the channel.

Remove sediment accumulated behind the dam as needed to allow channel to drain through the stone check dam and prevent large flows from carrying sediment over the dam. Replace stones as needed to maintain the design cross section of the structures.

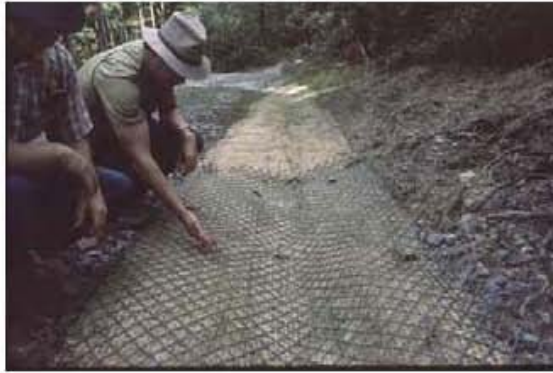
STANDARD AND SPECIFICATIONS FOR VEGETATING WATERWAYS

Waterways are a natural or constructed outlet, shaped or graded. They are vegetated as needed for safe transport of runoff water.
